NTSB National Transportation Safety Board

Office of Railroad, Pipeline & Hazardous Materials Investigations

Macdona, Texas

Chlorine Release

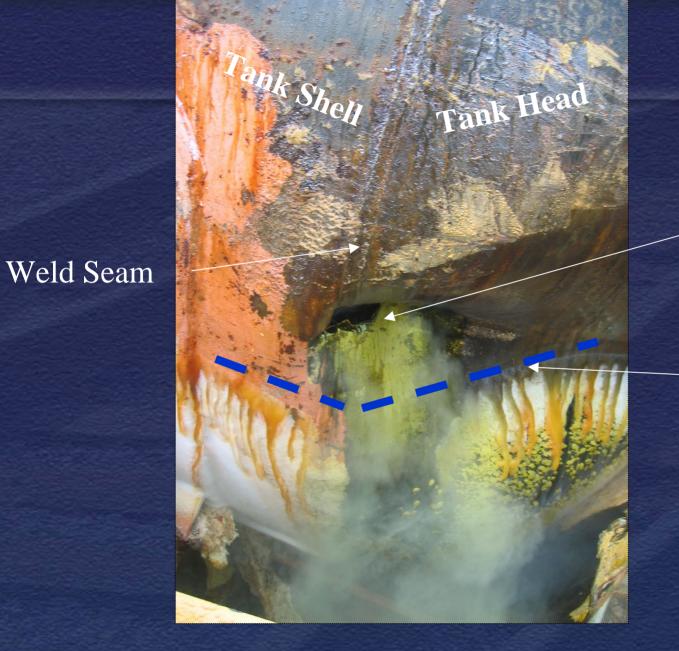
Puncture (2" x 11')

Frost Line

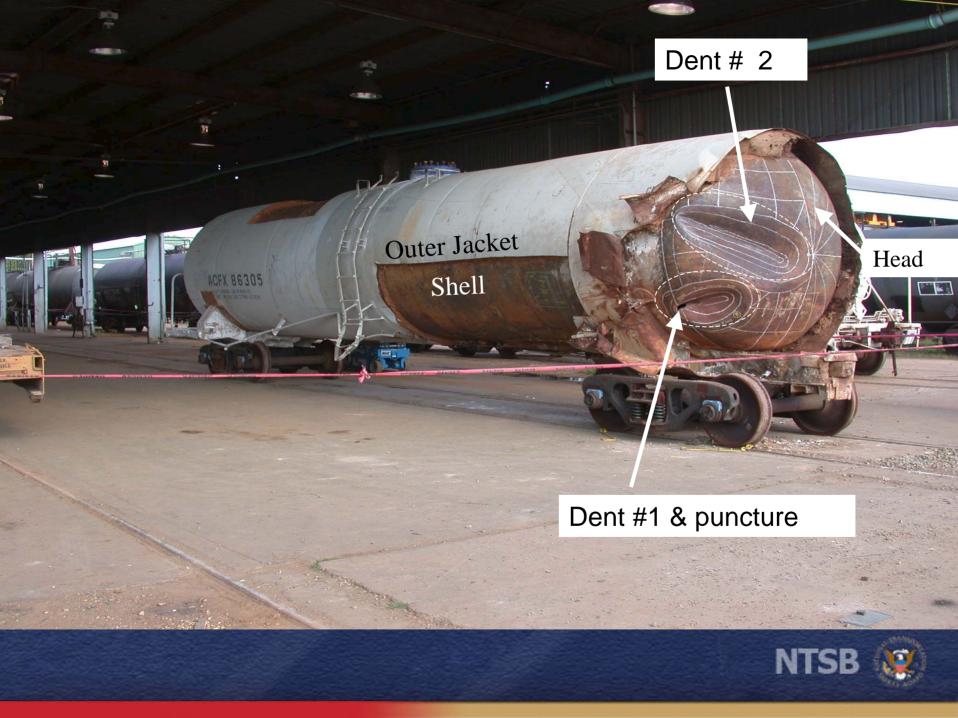
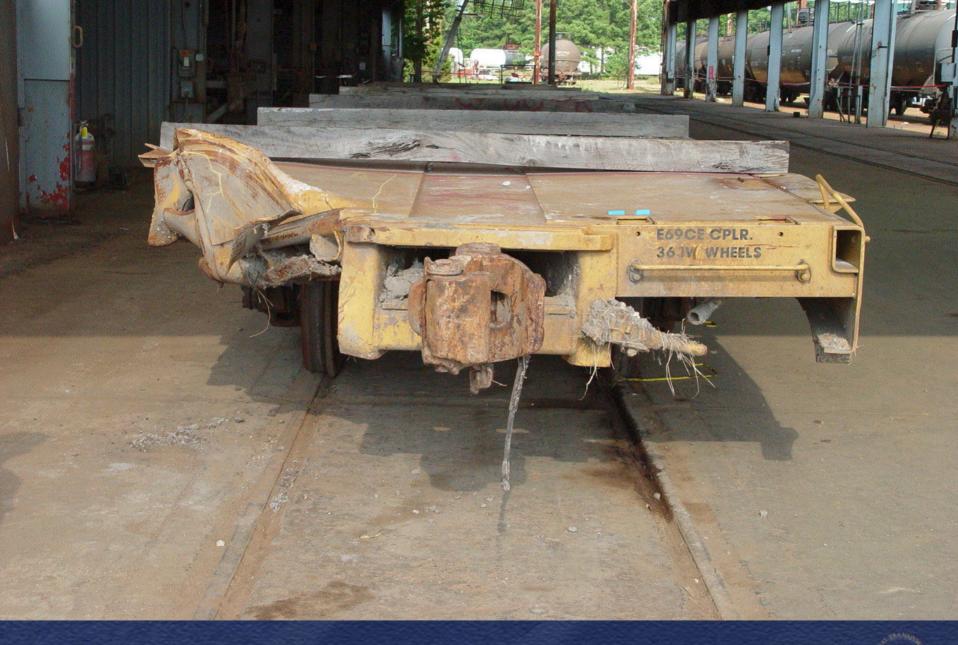
Punctured Tank Car

- Manufactured in 1976
- Insulation & outer steel jacket
- Tested to 500 psig
- Tank Shell
 - $-\frac{3}{4}$ inch thick
 - Non-normalized steel
- Tank Heads
 - -13/16 inch thick
 - Hot formed steel

- Tank head
 - DBTT $< -40 \, \mathrm{^o}\,\mathrm{F}$
 - Ductility limited puncture
- Tank shell
 - DBTT $> 85^{\circ}$ F
 - Brittle under most operating conditions
